DEPARTMENT OF TRANSPORTATION

Contract #: 04-0120F4Cty: SF/ALA Rte: 80 PM: 13.2/13.9File #: 69.28**WELDING INSPECTION REPORT****Resident Engineer:**Siegenthaler, Peter**Address:** 333 Burma Road**City:** Oakland, CA 94607**Report No:** WIR-024035**Date Inspected:** 20-May-2011**Project Name:** SAS Superstructure**OSM Arrival Time:** 700**Prime Contractor:** American Bridge/Fluor Enterprises, a JV**OSM Departure Time:** 1900**Contractor:** Zhenhua Port Machinery Company, Ltd (ZPMC), Changxing Island **Location:** Shanghai, China

Segment 13AE, Bearing Block Assembly (for Anchor Bolt Seat) at OBG Trial Assembly

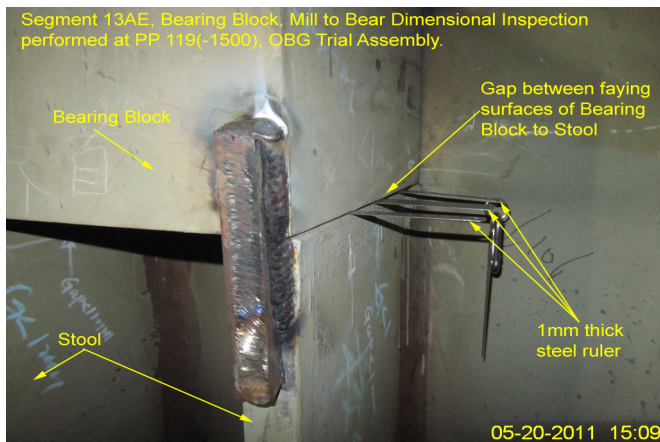
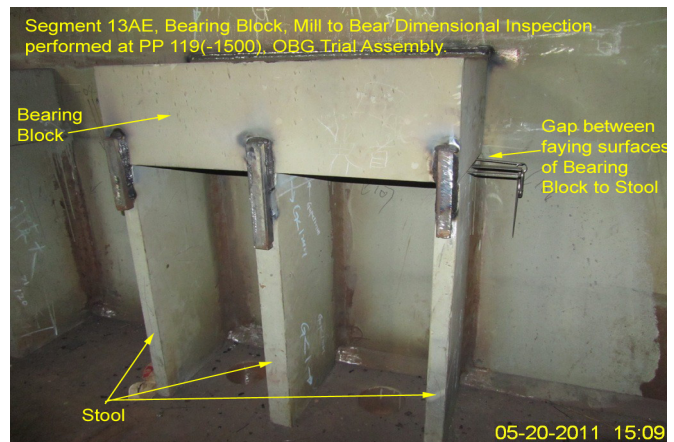
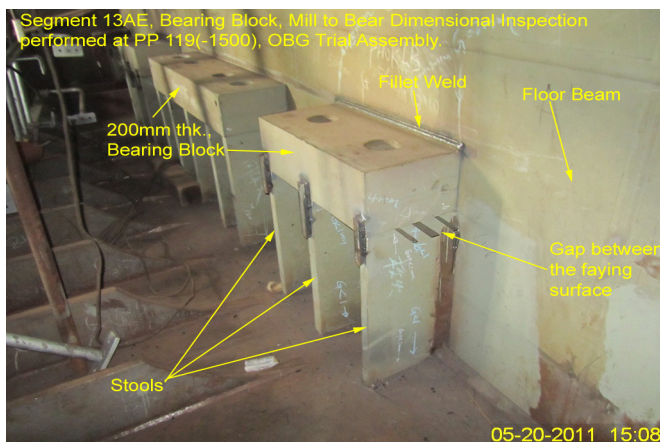
Note: During the process of Dimensional Inspection observed welder # 067148 performing fillet welding to the Bearing Block (200mm thick) to the Floor Beam at PP 119 (-1500) West side, observed 1mm gap between the vertical stool top face to the bearing block, it was confirmed by sliding the 1mm thick steel ruler inside the faying surface.

Informed the observation to the Caltrans Lead Inspector Mr. Rodney Patterson and Mr. Mark Miller and Mr. Wang of ABF. The welding was stopped after observing 1mm gap after fillet welding. Thus observed gap not in compliance with the contractual requirement.
